# SERVICE NOTES

Service Bulletin FSN-30

Subject: NC-300 Changes

Bulletin Number FSN-33

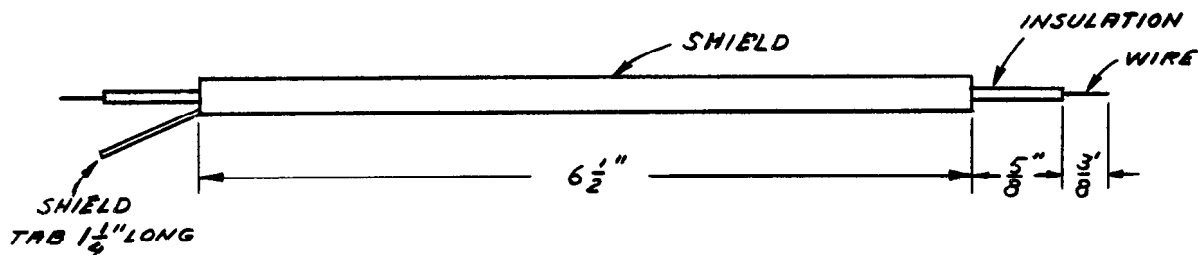
A shielded lead should be constructed as shown below:

- A. Replace shielded lead from L4 to grid of second converter, V3 with above lead, placing it under phasing control shaft as shown in the pictorial diagram below.

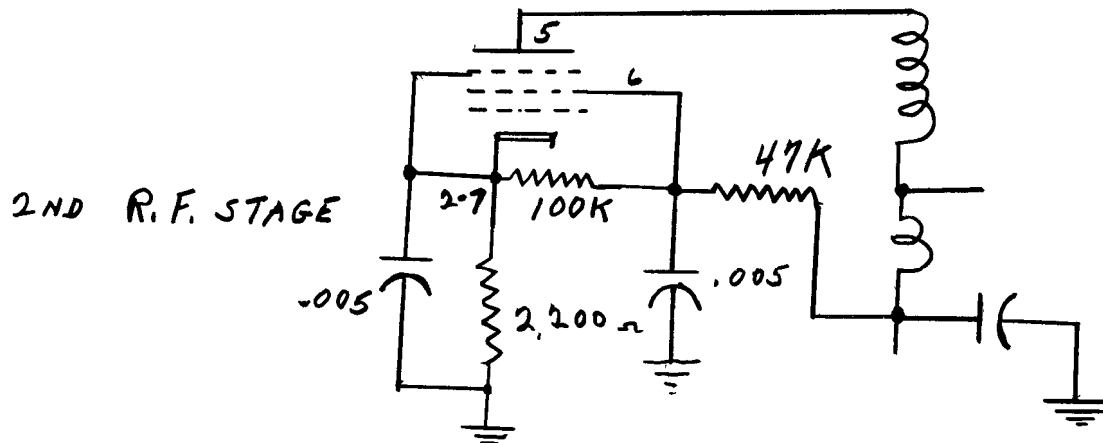
Revised circuit below:

The following changes are recommended in the 6-meter converter to reduce cross-modulation:

Change cathode resistor in 6AK5 2nd R.F. amplifier stage from 470 ohms  $\frac{1}{2}$  watt to 2200 ohms  $\frac{1}{2}$  watt

A 100,000 ohm  $\frac{1}{2}$  watt resistor should be connected between Pin #6 and Pin #2 - 7 of the same 6AK5 2nd R.F. stage

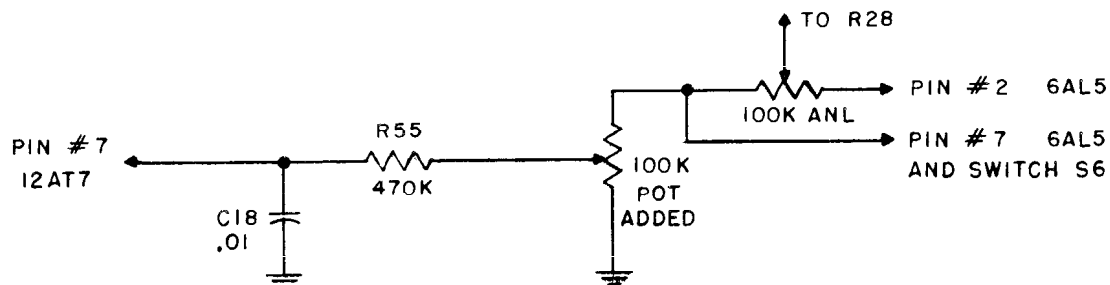
Some users of the NC-300 have complained about the fact that the "S" meter on the NC-300 seemed too sensitive. This may be adjusted in two ways to satisfy the individual user.

1. To decrease sensitivity of the "S" meter by a fixed amount, decrease the value of R-30 (68K 1/2 watt).
2. To decrease or increase the sensitivity of the "S" meter by a variable amount, replace R-43 (33K 1/2 watt) and R-30 (68K 1/2 watt) with 100 K potentiometer, connect arm of potentiometer to R-55 (47-OK 1/2 watt).

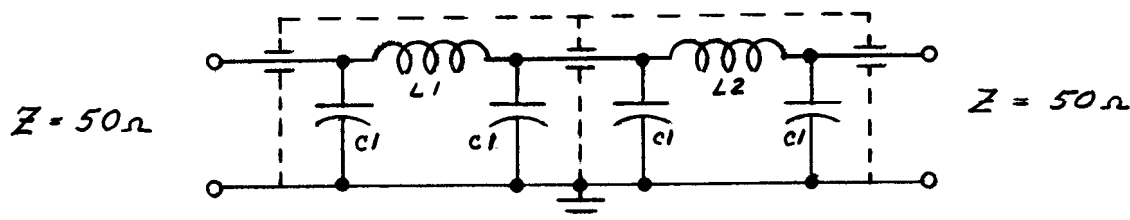
In certain metropolitan areas, I.T.V. is experienced on the 21 mc, 28 mc and X bands of the NC-300. This can be minimized by proper selection of antenna and the use of a low pass filter shown in the diagram below. This filter should be inserted in series with the antenna and located as close as practicable to the antenna terminals on the back of the chassis. A good earth ground helps considerably.

$L_1$  = .4 uh      10 Turns #20 on 3/8" form spaced 1/2"

$C_1$  = 80 uuf Ceramic

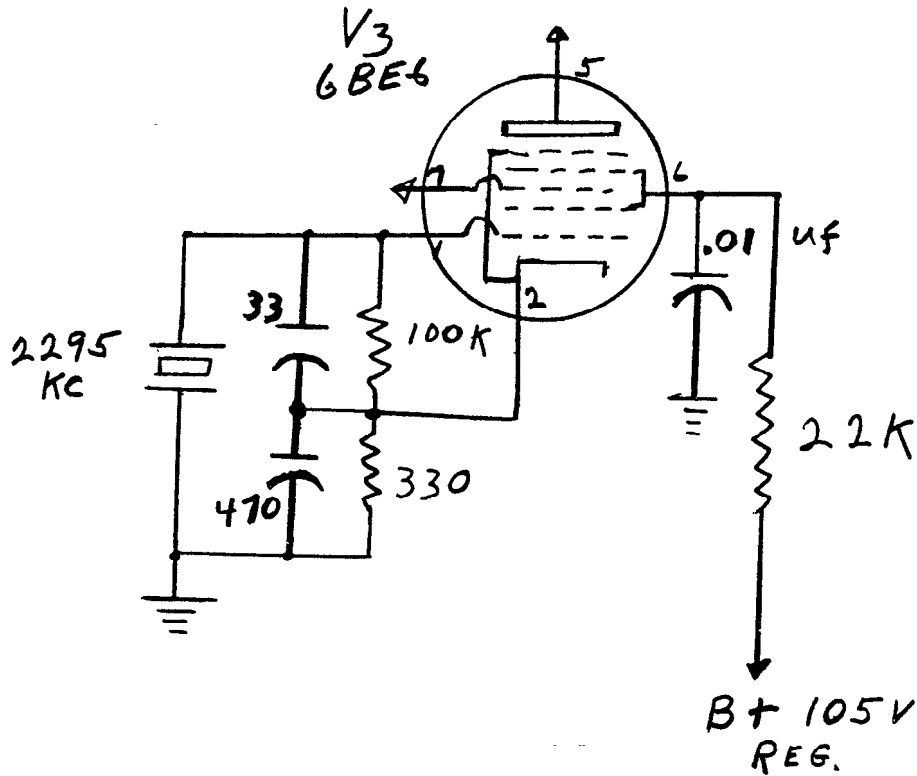
This time of year with relatively high heat and humidity usually brings sporadic reports of calibration errors and ineffective crystal filter action in the NC-300. This is due to the second conversion oscillator coil having drifted off its correct frequency of 2295 kc.

In most instances all that is necessary is that L6 in T5 be trimmed to the correct frequency by means of the slug in it. There are other rare cases where the second conversion oscillator will not maintain its frequency for more than a period of a month or so. These reports usually originate in areas of high humidity such as Florida and Louisiana and other localized areas.

In these instances we recommend crystal control of the second conversion oscillator as per the attached schematic. It should be remembered that there are now two crystals in the circuit which must be properly coordinated if the receiver is to work at maximum efficiency. Normal production tolerances in the grinding of the crystals may allow a situation to exist where the difference in frequency of the crystal in the crystal filter (2215 kc) and the crystal in the second conversion oscillator (2295 kc) is not exactly 80 kc (second IF).

If this is so the second IF strip must be adjusted accordingly either slightly higher or slightly lower to compensate.

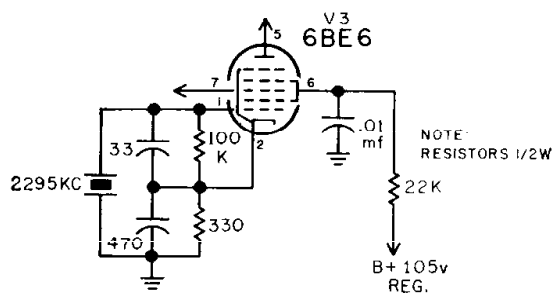
Fig. 1—Crystal controlled second converter.

The summer months of the year occasionally bring reports of calibration errors and ineffective crystal filter action in the NC-300, particularly in areas of high humidity. This is due to the second conversion oscillator drifting off its normal frequency of 2295 kc. This situation is evidenced by calibration errors on the dial in one direction on the high frequency ranges and in the opposite direction on the low frequency ranges and also by erratic operation of the crystal filter.

It is a simple matter to crystal control the second converter oscillator which effectively eliminates these problems.

The crystal and its associated components may be mounted in the shield can which formerly housed L6 the second conversion oscillator coil.

It should be remembered that there are now two crystals in the circuit which must be properly coordinated if the receiver is to work at maximum efficiency. Normal production tolerances in the grinding of the crystals may allow a situation to exist where the difference in frequency of the crystal in the filter (2215 kc) and the crystal in the second conversion oscillator (2295, kc) is not exactly 80 kc (second IF). If this is so the second IF strip must be adjusted accordingly, either slightly higher or slightly lower in frequency to compensate.
